Thermal Imaging Scan Reveals the Truth Behind the Wall

Peter Hopkins, Certified Thermographer
SoCal Infrared (www.socalinfrared.com)

SUBJECT PROPERTY "Author's Brand New Home"

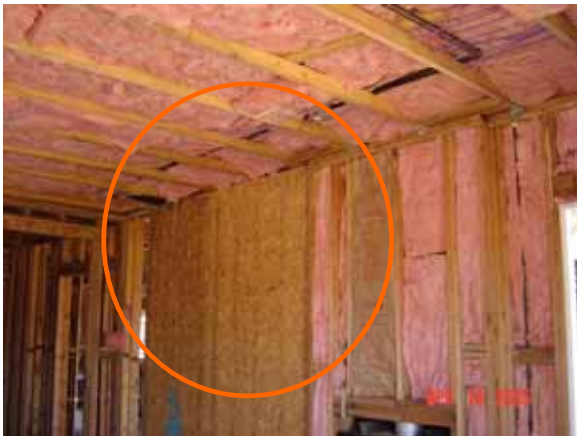
During a framing walkthrough with home builder, it was noticed that the design of the building had shear paneling installed on the interior portion of the wall in the master bedroom (Figure 1), and the exterior weatherproofing paper had already been applied. The builder was questioned on how this exterior portion of a wall was insulated as the insulation was put in after the weatherproofing was applied. The Builder responded that it was taken care of. This created questionable integrity, as it would be difficult to prove. Further review was needed and homeowner "Hopkins," being a building inspector by trade, proceeded to look further into.

Figure 1. Exterior wall showing shear paneling on interior wall.

Shear paneling is typically installed on the outside of a house, however the engineer's design also included shear paneling on the interior of the home in the master bedroom. By using this construction method, the builder should have known to insulate the wall before applying the building wrap.

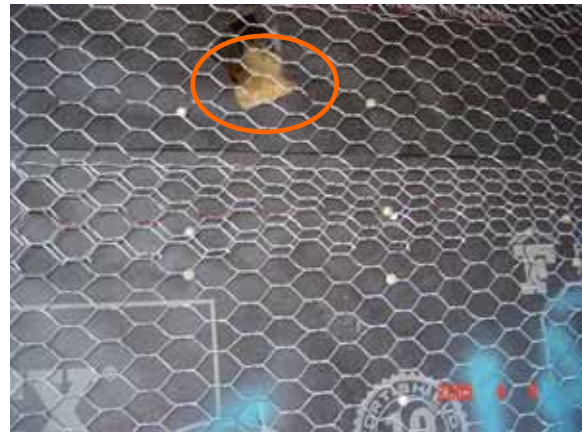
Figure 2. A small hole was cut in exterior paper confirming suspicion of missing insulation.

Knowing that leaving just one wall un-insulated can make quite a difference (see table and image, figure 7) in room temperature and wasted energy, the builder was informed of the problem, and requested that the wall be fully insulated. The lower portion of wall was exposed by an electrician running last minute wiring prior to stucco (figure 3). The builder's work team returned to supposedly finish the job. Hopkins the homeowner knew that fire blocking is installed about 4 feet up from the bottom limiting their ability to install insulation in the upper portion. He became suspicious and decided to check out the workmanship. The homeowner cut an opening in building paper (figure 2) to expose missing upper insulation. With marking paint in hand, the homeowner decided to make it more visible to the builder. The original hole was patched over later by builder (figure 4) and the homeowner was once again informed that it was complete.

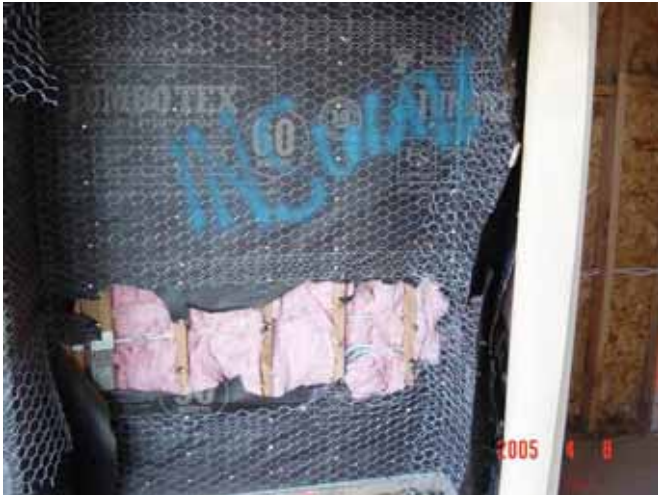
Figure 3. Electrician had to run last minute wiring, builder insulated lower portion at this time.

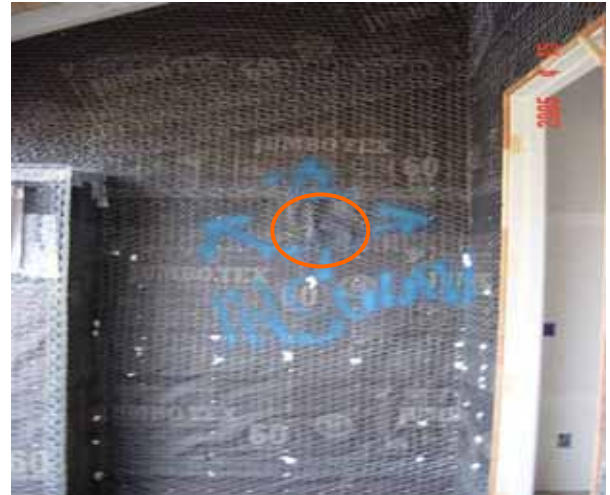
Figure 4. After hole cut in top portion of wall to show missing insulation (figure 2), builder patched hole over.

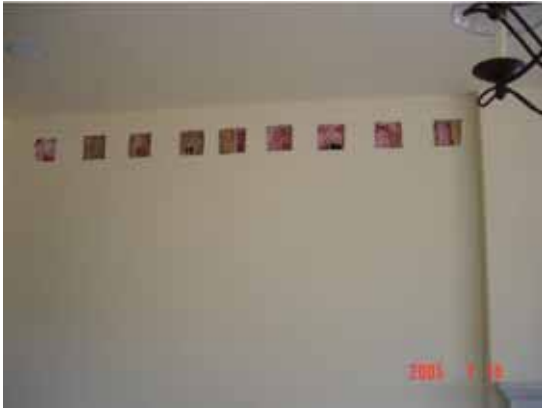
After the homeowner moved in several months later and repeated requests to verify that the wall was properly insulated, the builder returned at the homeowners request to verify that the wall in the master bedroom had in fact been fully insulated. Nine holes were cut along the top of the wall to reveal that insulation was provided (Figure 5). Unfortunately, the opening of wall was done when homeowner was not present.

Figure 5. Nine holes cut in drywall/shear panel

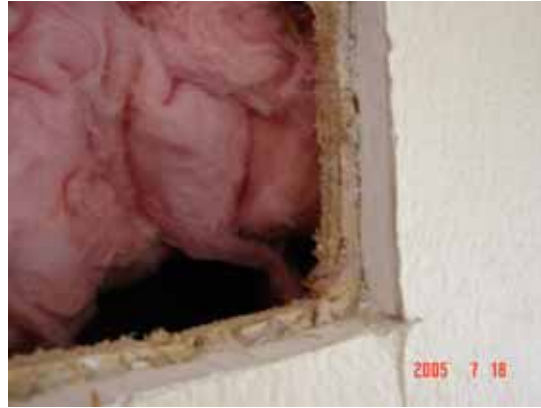
The first response from the builder was that wall was fully insulated. The homeowner, suspicious, decided that further review was necessary. Looking closely (Figure 6) at openings in the wall identified that fiberglass thread remains at shear panel were on every cut. It was suspected that the insulation was shoved into each opening prior to homeowners' arrival and presented as a fully insulated wall. The homeowner pulled samplings of these pieces of insulation out of wall to find that they were a maximum of 12 inches. The builder was informed of this finding, and came back next day and stated that it was now going to be fixed properly. Unfortunately the homeowner was once again unable to be present during their repair.

Figure 6. Close up of hole cut showing insulation threads on shear panel.

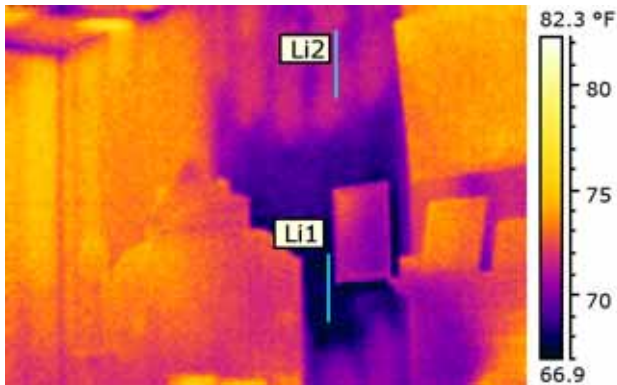
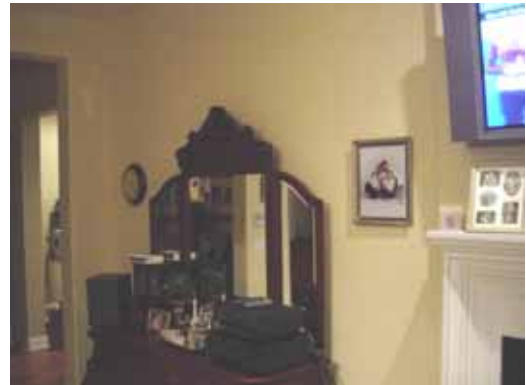
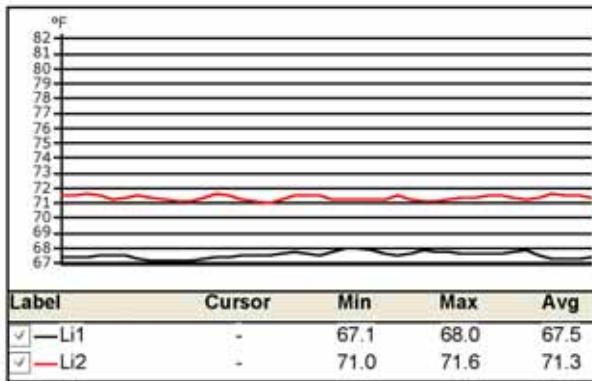
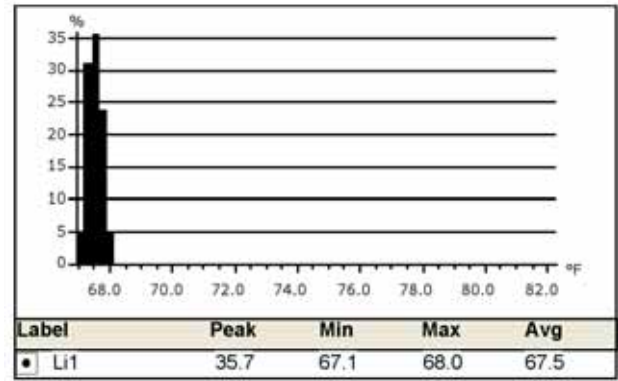
Figure 7. Thermal Pairing showing thermal and visible image of affected areas. Darker areas on thermal show missing insulation. Histogram showing average line temperatures comparing insulated/non-insulated area.

The thermal scan did indeed confirm that a four-foot space across the center of the wall remained uninsulated. The builder at second repair only shoved about 3 feet of insulation into wall. By capturing immediate documentation with the infrared camera, Hopkins was able to prove his case in point, leaving the builder no other choice but to remedy the situation.

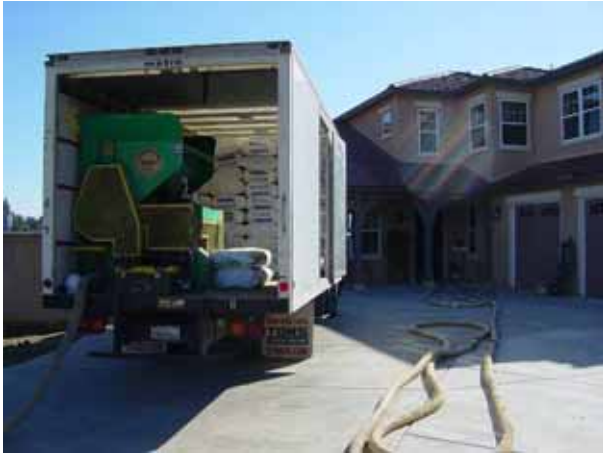
Figure 8. Insulation remediation.

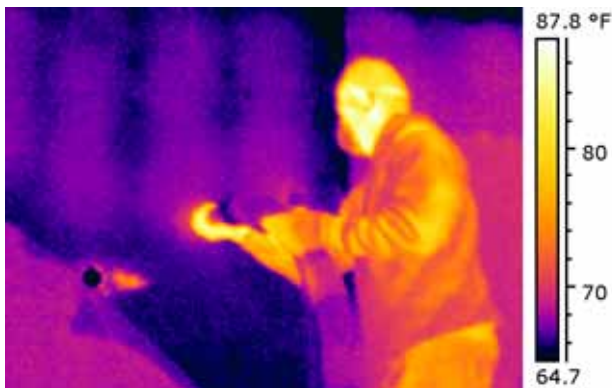
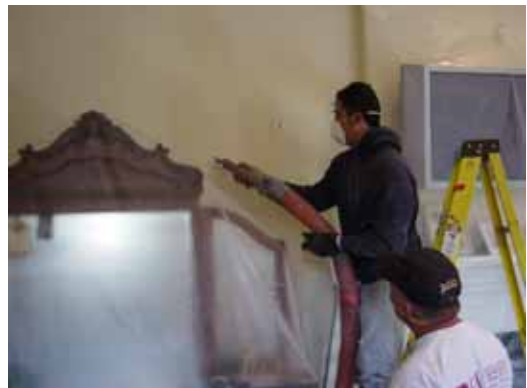
Figure 9. Thermal of contractor blowing in insulation, wall being insulated.
